TNO-report Div400.

## The effect of DME on wear of fuel pump parts

December 2000

Project number 007.40354

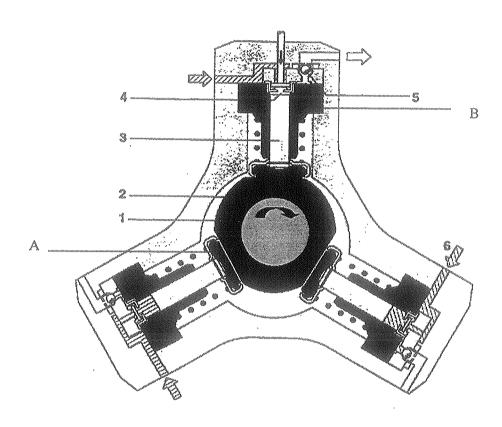
Figure 1 Cross section of the high-pressure pump. The selected tribological systems are:

- Sliding contact between the cam (2) and the plunger tappet (A);
- Sliding contact between the plunger shaft (3) and the bushing (B).

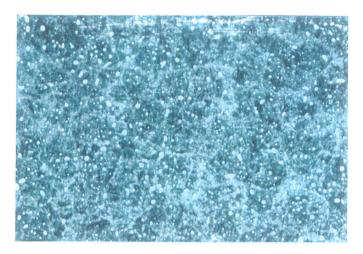
The plunger tappet surface consists of a homogeneous steel, which is trough hardened. The Vickers hardness of the plunger tappet is  $780~\text{HV}_{5\text{kg}}$ . Structure images (see Figure 2) reveal a fine martensite structure containing chromium carbides. Optical emission spectroscopy (OES) strongly suggests that the tappet is made of 100Cr6, a common ball bearing steel. The main components of 100Cr6 steel are summarised in table 1.

Figure 2 Structure of the plunger tappet. M = 1000 x [L2784]

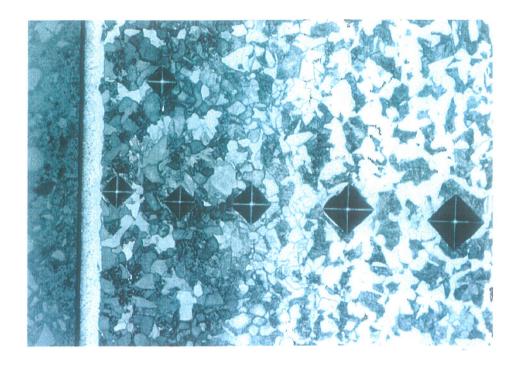
A representative cross section of the cam is shown in figure 4. The structure of the matrix changes when approaching the outer surface of the cam, indicating a heat treatment like nitriding of carburising. A thin hard layer of about 20  $\mu$ m is present at the outer surface of the cam. The hardness of the cam increases from about 160 HV<sub>5kg</sub> / 170 HV<sub>0.5 kg</sub> to 500 HV<sub>0.5 kg</sub> at the centre of the cam to 500 HV<sub>0.5 kg</sub> just below the contacting surface, to 930 HV<sub>10g</sub> at the outer 20  $\mu$ m of the cam.

Figure 4 Cross section of the cam, showing hardness indention marks. M = 200 x [L 2796]

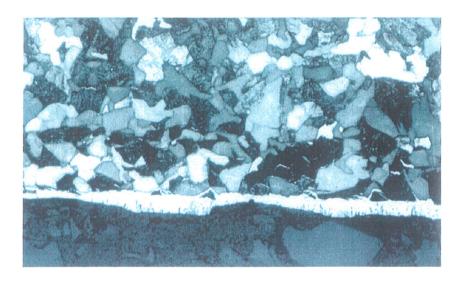
The structure of the cam doesn't change in the wear scar. This can be seen from Figure 5. Although part of the surface layer has been removed due to the sliding action it is still protected from direct contact with the softer layer just below the surface. The same conclusion can be drawn by comparing the EDAX analyses of the wear scar on the cam surface and a part of the same surface that has not been in contact with the plunger tappet (Figure 6). The spectra look similar and are quite common for steel surfaces used in sliding contacts. Iron, Chromium and Silicon are common for steel. The presence of Sulphur, Phosphorus and Barium indicate the use of a lubricant or the use of diesel fuel. Another possibility is that part of the grinding coolant fluid is still present at the cam surface. No relative changes in elements counted, can be seen when comparing the spectra of the worn and initial surface of the cam. The high amount of oxygen could be due to the heat treatment of the cam.

Figure 5 Cross section within the wear scar of the cam. M = 500 x [L2781]

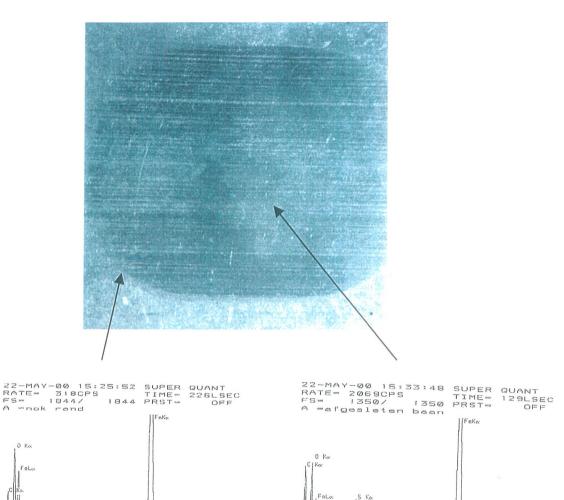
Figure 6 EDAX spectra for initial (left) and worn (right) cam surface. M = 3.1 x, [L 9841]

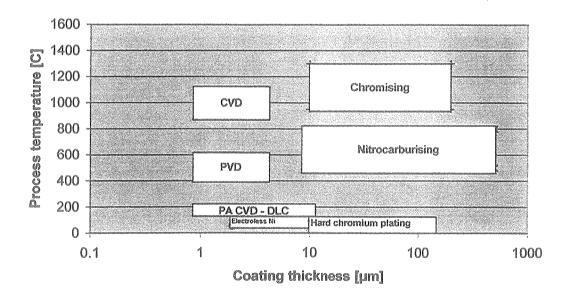
Figure 7 shows a representative cross section of surface treatment techniques, commonly used in industrial and automotive application. From this figure it can be seen that a large variety of process temperatures and layer thickness exists. The actual application window is determined by the maximum allowable dimensional changes of the pump parts and by the present heat treatment of the steel. The latter is quite important because of the fact that a hard matrix is needed to support the applied layer. Otherwise an egg-shall situation is created, with the risk of immediate failure due to cracking and spalling of the layer. A hard matrix will loose its hardness when it is heated above the tempering temperature that is used in the hardening process of the steel.

Figure 7 Representative cross section of available surface treatment techniques

From the set of available surface treatments it is expected that physical (PVD) or chemical vapor deposition (CVD) processes will have a large change of success in this application. These processes are flexible in the sense that a variety of compositions can be produced. Furthermore thin and very hard layers with uniform properties can be made. Grinding, polishing or other mechanical or chemical post treatment is not needed, contrary to for example hard chromium plating.

The materials used in the application are rather difficult to treat with PVD or CVD processes. Especially 100Cr6 is difficult to process because of the low tempering temperature of the steel: 180°C. Plasma assisted CVD processes (PA CVD) producing diamond-like-carbon (DLC) layers are a positive exception on the rule. The self-lubrication properties of this category of layers is proven in a number of papers and case studies.
